RADC-TR-82-43
Final Technical Report
March 1982

QUALITY ASSURANCE PROCEDURES FOR LSI

Martin Marietta Corporation

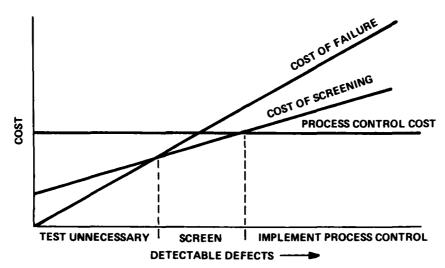
Figure 1. Screening justification curve.

for the added value of the rejected units compared to the cost of performing a preventive process control. Figure 1 shows a simplified diagram of this relationship. At the extreme left, the product has a sufficiently low inherent percent of defects that no additional process control or screening test is justified. In the center region, screening dominates because the cost of failure exceeds the screening cost, which is less than the additional process control cost. To the right, the process control is dominant because the increasing yield loss has caused screening to be a more costly method of preventing field failures. In the extreme case, low screening yields would prevent product shipment and further strengthen the case for process controls.

This analytical technique is based on average reject rates and makes the assumption that both the screen and the process control are properly designed to detect the weakness of interest regarding possible subsequent failures. If it is found that individual lots fall almost exclusively in either the first or third region but the average is in the second region (screening dominant), a further analysis may be warranted to determine a low-cost precursor to the need to screen or to reject the entire lot.

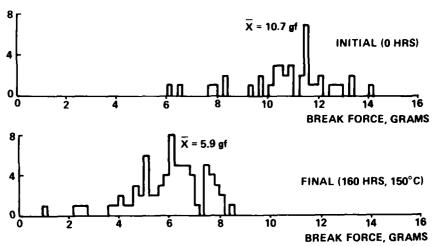
Figure 17. Expected degradation of Al wire bond strength on normal Au thick film.

The 39-percent decrease in mean bond strength in Figure 17 is attributed to the expected annealing of the aluminum. Since this gold thin-film system is not normally suitable for Al ultrasonic bonding, the wide dispersion of bond strengths is also expected and desired to produce a strength distribution appropriate to evaluate mechanical stress tests. The Au wire bond strengths shown in Table 16 are representative of normal product.

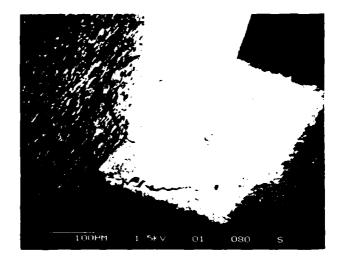
Figure 23. Loss of thick-film adhesion during temperature cycling.

Figure 23 depicts a typical problem which can be attributed to insufficient adhesion between the thick-film metallization and the ceramic substrate. This example, taken from an internally funded study, shows a platinum-gold solder pad which has begun to lose adhesion after 50 temperature cycles in a ceramic chip carrier assembly test. This type of cracked appearance, which is actually thick-film liftoff, is also typical of that seen around some capacitor solder terminals following temperature cycling.

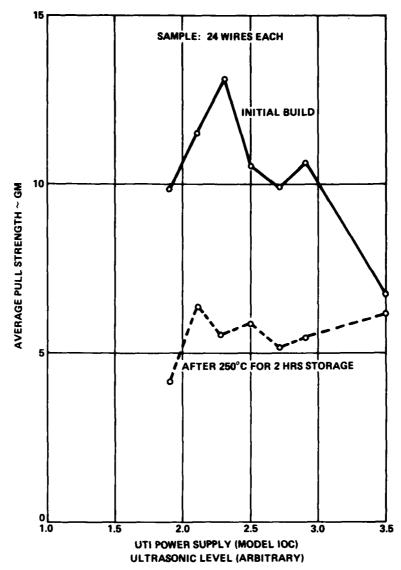
Figure 24. Variation in pull strength for Al wire on Au.

For each lot fabricated in the Evaluation Phase, a nonfunctional sample having approximately 30 wire loops of Al or Au wire was made as part of the lot. These units were subjected to 1 hour at 300°C and then destructively pulled to the postseal levels of Method 2011.2. Decrease of wire bond strength with temperature is a function of several variables that generally cannot be accurately predicted. Figure 24 shows the temperature response of aluminum wire bonds to gold-plated package posts as the power supply setting was varied on the ultrasonic bonder. In this sample the bonds having the highest initial strength suffered the greatest percentage of reduction in strength when subjected to 250°C for 2 hours.

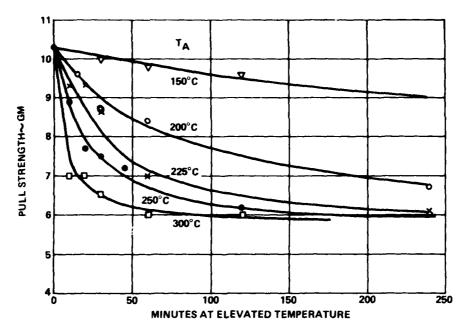
Figure 25. Al wire to Au bond strength temperature response.

Figure 25 gives an indication of the rate of temperature effects on bond strength. These data exhibited an activation energy of 0.49 \pm 0.1 eV for the degradation rate of bond pull strength based on the initial slopes. It should also be noted that for each temperature, there was an apparent lower limit to bond strength which was not reached in the case of those exposed at 150 and 200°C.

On the basis of such data, combined with a recent production lot that exhibited near-zero strength following temperature stress, the process control of subjecting a sample to destructive bond pull test following 2 hours at 250°C was instituted for the Verification Phase.

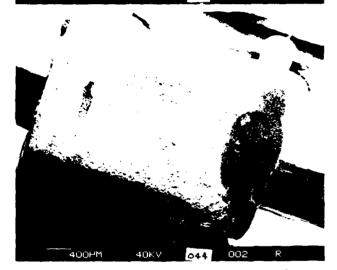
PHOTOGRAPA 2 21X

BOTTOM OF LOOSE CHIP CAPACITOR.
